Home Inspection Report

981 Cape Buffalo Drive, San Jose

Russ Hume
May 21, 2015

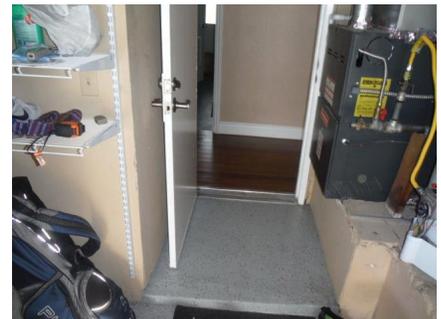
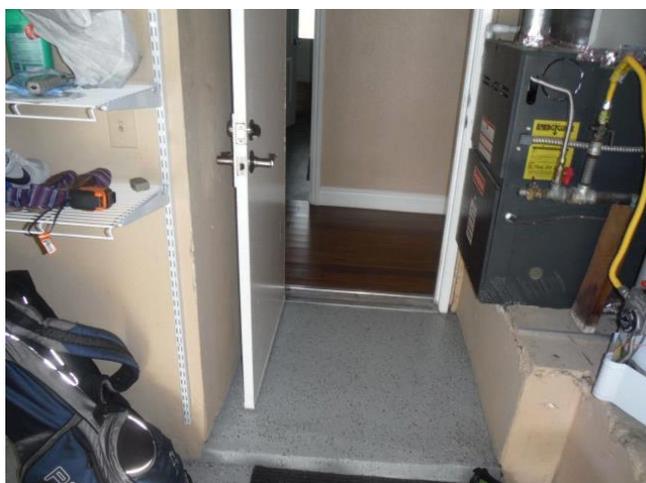
Photo 5

- ! 1. The auto door closer between the garage and the house did not function properly. The auto closer mechanism on the passage door between the garage and the interior of the house should be adjusted or repaired to close automatically. This will reduce the potential of toxic automobile gases entering the house and serves as a fire break. (See Illustration 6A) (See Photo 5)

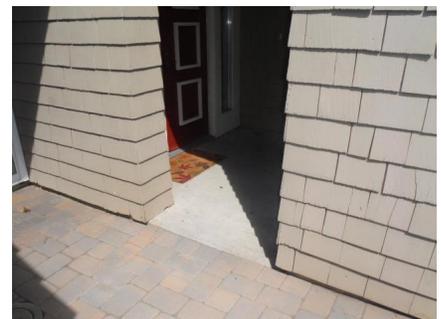
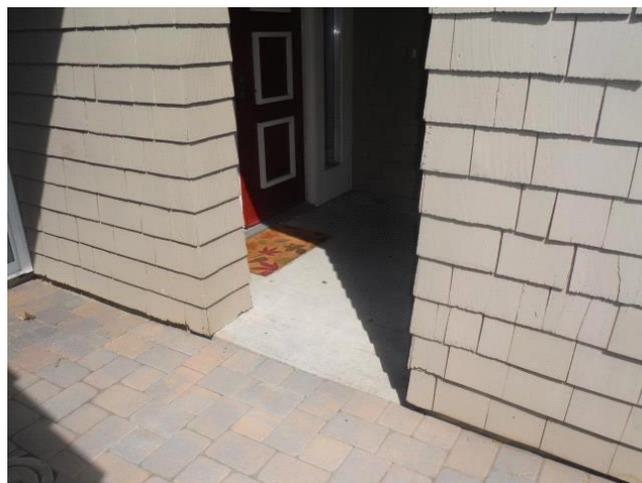
Photo 4

- ! 2. Water damage was observed to the wood siding in the exterior walls. We recommend the services of a licensed general contractor and/or structural pest control company. (See Photo 4)

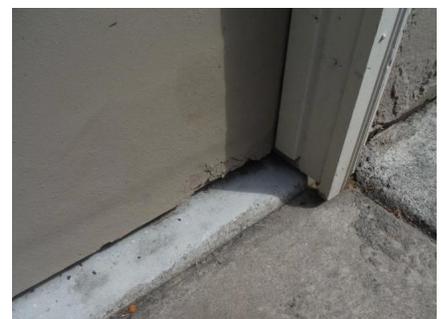
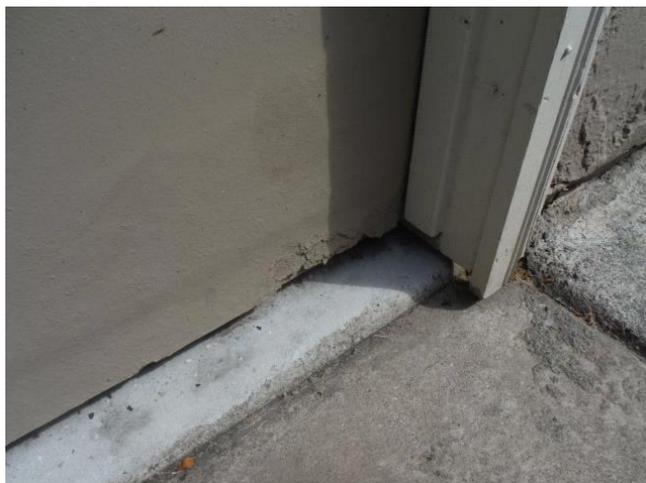
Photo 1

- ! 3. The exterior side or rear garage door is water damaged. We recommend the services of a licensed general contractor and/or structural pest control company. (See Photo 1)

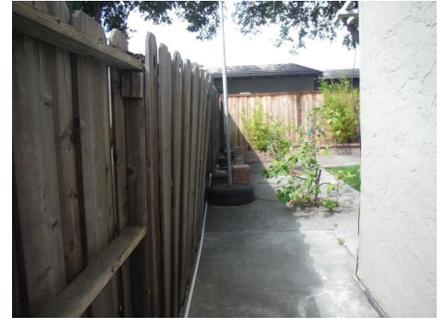
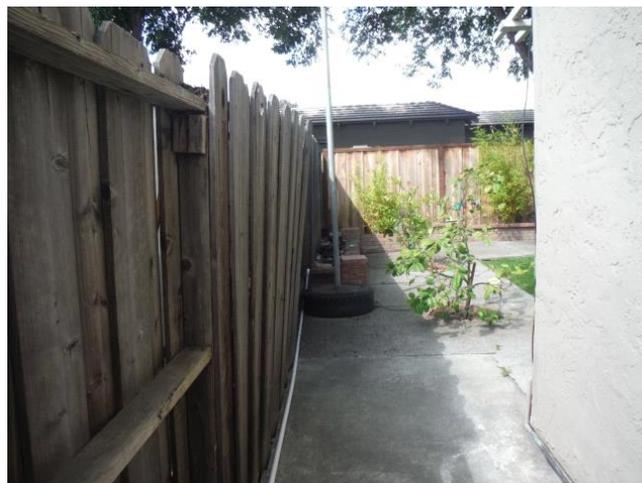
Photo 2

4. The fence is in satisfactory condition, however one or more of the fence posts are loose at the left side. We recommend all loose, damaged or deteriorated post be reinforced or replaced as necessary. (See Photo 2)

- ! 4. The fence is in satisfactory condition, however one or more of the fence posts are loose at the left side. We recommend all loose, damaged or deteriorated post be reinforced or replaced as necessary. (See Photo 2)

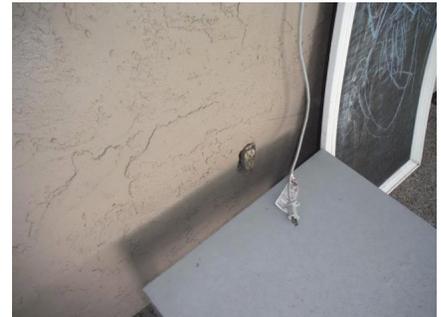
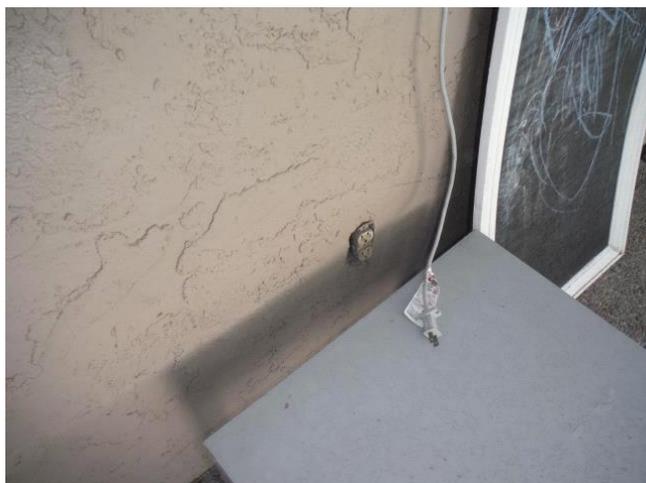
Photo 3

5. Exterior receptacles at the rear are missing a water proof cover plate. We recommend a exterior approved cover be installed. (See Photo 3)

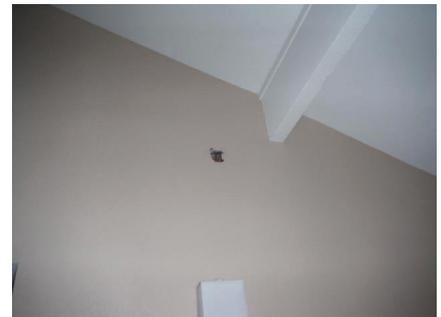
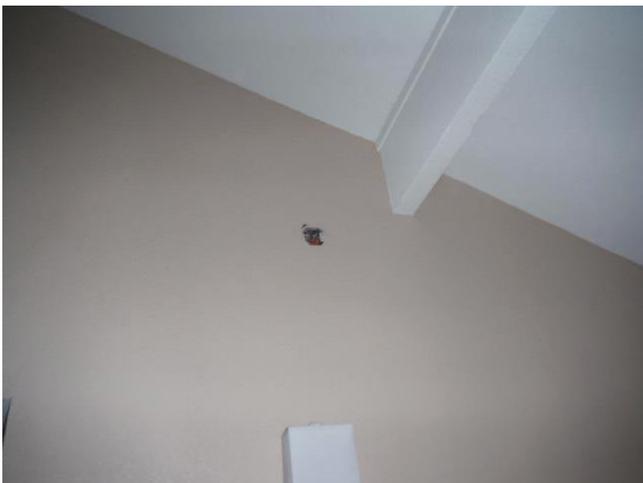
Photo 11

6. Exposed electrical connections or open junction boxes at the upstairs should be corrected. All electrical connections should be made inside approved junction boxes fitted with proper cover plates. (See Photo 11)

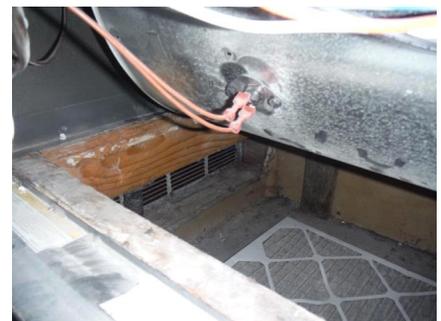
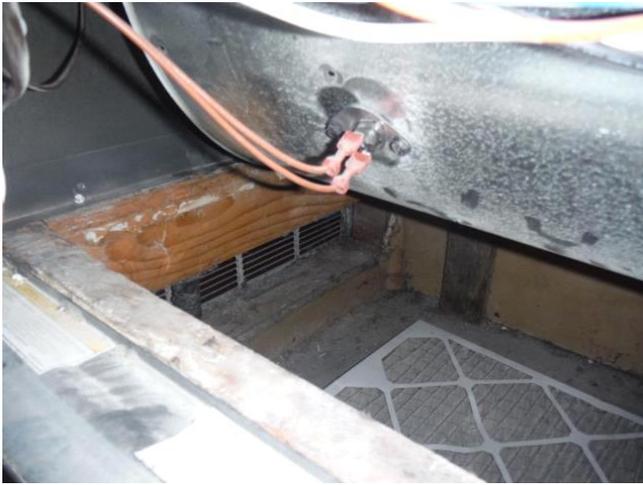
Photo 7

7. The missing furnace air filter should be replaced. This will help keep dust from re-entering the occupied interior and help keep the blower and duct work clean. (See Photo 7)

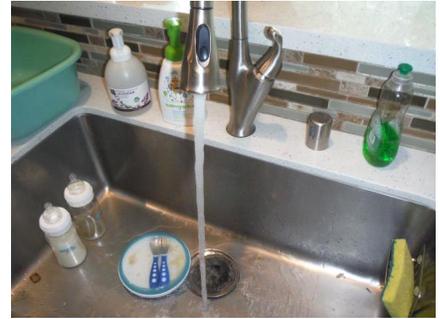
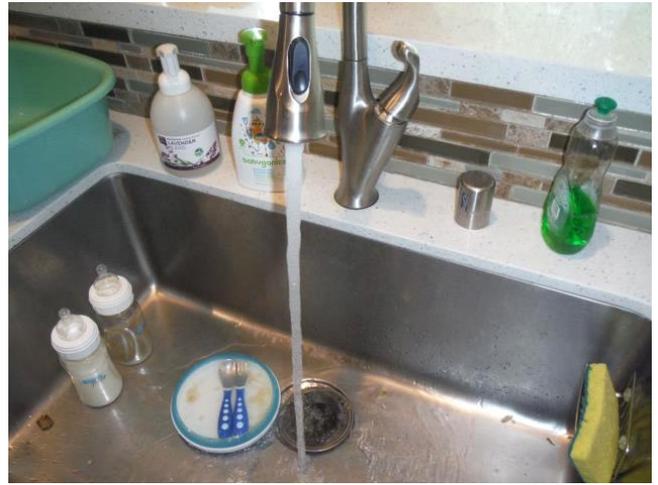
Photo 8

8. The kitchen sink faucet hot and cold water controls are reversed. Reversed hot and cold water can result in hot water burns. We recommend that this condition be corrected. (See Photo 8)

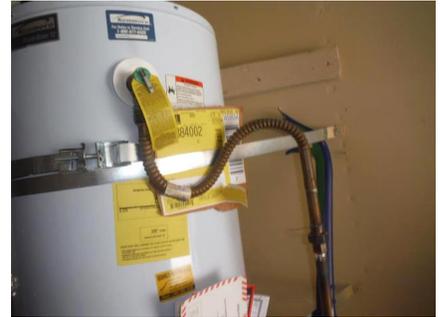
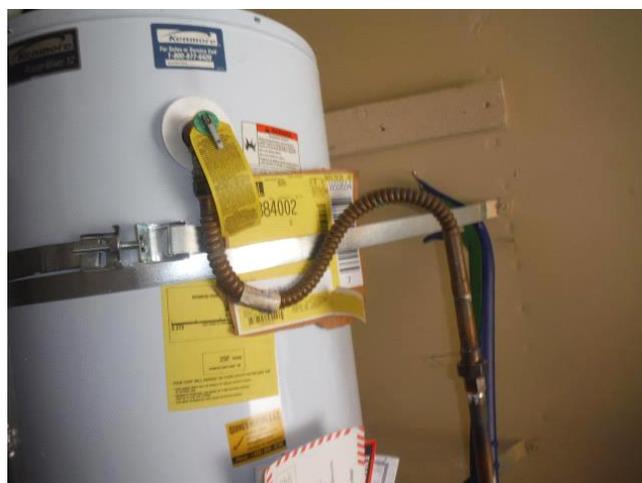
Photo 6

9. The temperature and pressure relief discharge pipe for the water heater is improper. We recommend the installation of a proper discharge pipe to an approved location. (See Photo 6)

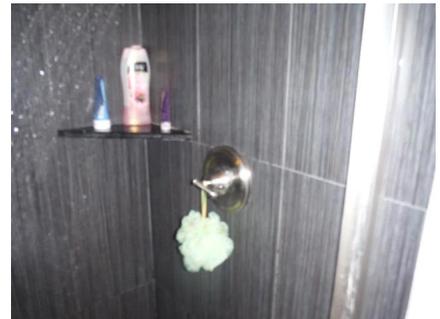
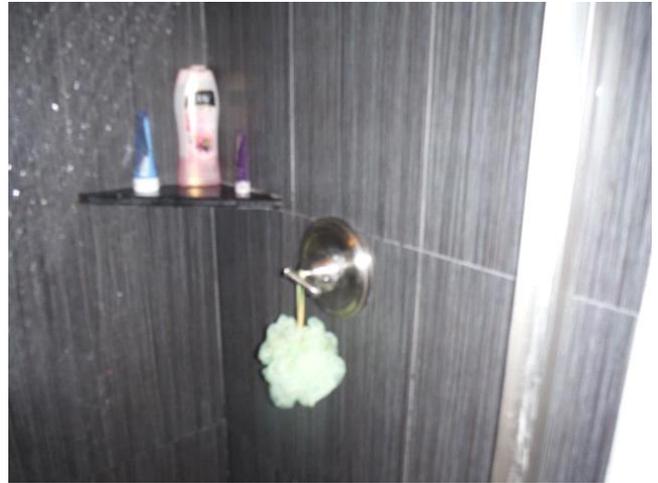
Photo 10

10. The master bathroom shower faucet hot and cold water controls are reversed. Reversed hot and cold water can result in hot water burns. We recommend that this condition be corrected. (See Photo 10)

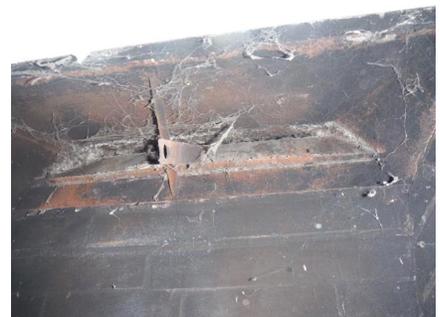
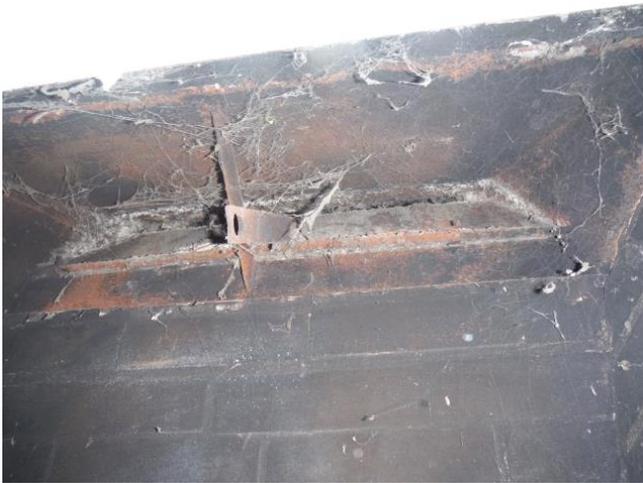
Photo 9

11. The fireplace damper is damaged and/or not operational. We recommend it be repaired or replaced. (See Photo 9)

- ! 1. The fireplace damper is damaged and/or not operational. We recommend it be repaired or replaced. (See Photo 9)
- 2. One or more of the interior door(s) rubs on the frame/jamb. We recommend all rubbing doors be trimmed, planed or adjusted as necessary to improve operation.
- 3. One or more interior closet doors have been removed. We recommend that doors be installed in all necessary openings and checked for proper operation.
