## WOOD DESTROYING PESTS AND ORGANISM INSPECTION REPORT

Building No. <b>981</b>	Street <b>Cape Buffalo Drive</b>	City <b>San Jose</b>	ZIP <b>95133</b>	Date of Inspection <b>5/21/2015</b>	Number of Pages <b>Page 1 of 4</b>
----------------------------	-------------------------------------	-------------------------	---------------------	--	---------------------------------------

General Description: <b>Two story, single family wood framed residence with stucco exterior. Limited to the main structure only, excluding the overhang.</b>	Inspection Tag Posted: <b>Garage</b>
	Other Tags Posted: <b>None noted</b>

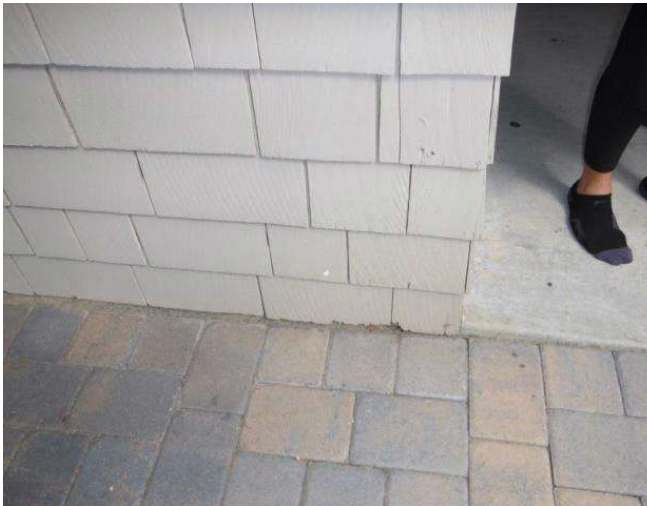
Picture 1

**1A. FINDING:** The siding has been damaged by fungus as indicated on the diagram. (See Picture 1)

**RECOMMENDATION:** Remove and replace all the damaged wood members. If any damage is found to extend into any enclosed areas a supplemental report and bid will be issued.

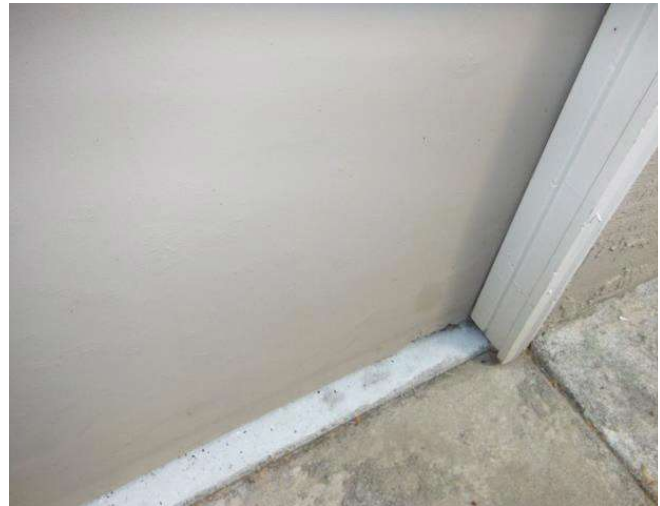
Picture 2

**1B. FINDING:** The side garage door has been damaged by fungus. (See Picture 2)

**RECOMMENDATION:** Supply and install a new door. We intend to reuse the existing hardware. We at HomeGuard Incorporated are upgrade experts and can provide proposals that include tile, marble, granite, upgraded fixtures, upgraded windows and doors or any other option you may desire.
